# Analysis of IAS Disagree Indicator Problems on ATR 72-600 using Fault Tree Analysis (FTA) Method

*The IAS Disagree system on the ATR 72-600 aircraft is a critical indicator that detects the difference in speed between the pilot's and copilot's sides. This study aims to identify and analyze the root causes of IAS Disagree indications using the Fault Tree Analysis (FTA) method. The research data was obtained from pilot reports and maintenance reports collected from Batam Aero Technic (E-MRO) servers over a period of two years and six months, namely from January 2023 to July 2025. The research sample consisted of 80 ATR 72-600 aircraft grouped by aircraft age, namely aircraft more than ten years old and less than ten years old. The FTA method is used to identify failure paths from basic events to top events through qualitative and quantitative analysis approaches. The results showed that of the 45 IAS Disagree incidents recorded, 31 occurred in aircraft more than ten years old with a probability of 0.69 or 69%. The FTA analysis identified six basic events as the root causes, with the pitot component having the highest contribution of 0.64 and the water computer data of 0.35. The ba

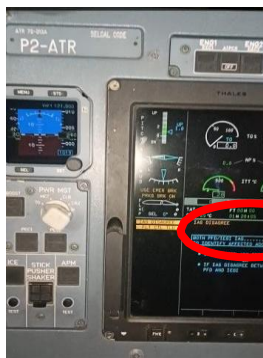
Figure 1. IAS Disagree Indicator Illuminated

Damage that often occurs in the *pitot* is the *pitot resistance out of range* or *resistance values* that are not in accordance with specifications ( $48 \pm 8$  Ohm), so that the *heater* does not function properly and can cause *icing* in the *pitot* when the aircraft is flying [9]. Another damage is *pitot leakage* which causes a loss of *pressure* that will be sent to the *computer data water* [8]. If this happens, the *pitot* must be replaced so that it can resume its function when the aircraft is in a flying condition. In addition, *pitot* can also occur due to contamination or *debris*, usually insects [10]. If this happens, then the *pitot* must be flushed.

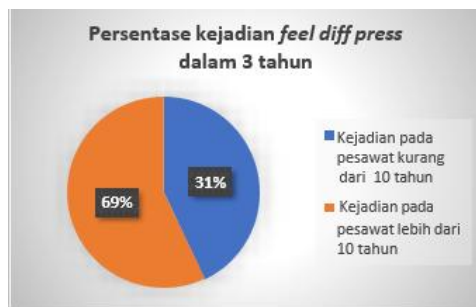
Based on the frequency of this incident, it can be seen that *IAS Disagree* is more common in aircraft that are more than ten years old with a percentage of 69%. This suggests that the age factor of the aircraft has an influence on the incidence rate of *IAS Disagree*, likely due to the degradation of components over operational time.

Figure 2. Percentage Chart of IAS Disagree Occurrence in Two Years and Six Months

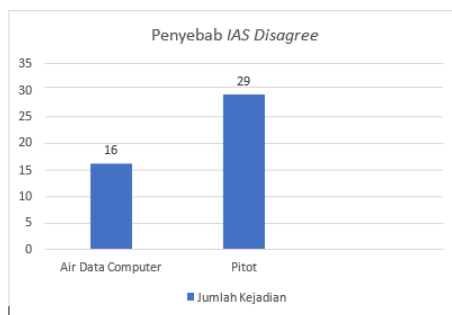
IAS Disagree events are also grouped by component that causes the indication to ignite. The top three causes of IAS Disagree indications come from *electrical bad contact*, *pitot line block*, and *pitot heating*. From the analysis of this data, it can be identified that problems in the *pitot* system are the main contributors to the occurrence of IAS Disagree.

Figure 3. Causes of IAS Disagree
